REHABILITATION AND STRENGTHENING OF
BURLINGTON NORTHERN SANTA FE RAILWAY
BRIDGE 482.1 OVER THE MISSISSIPPI RIVER
MEMPHIS, TENNESSEE

John W. Hronek & Ron G. Berry
HNTB Companies
1201 Walnut, Suite 700
Kansas City, Missouri 64106
Phone - 816-472-1201
Fax - 816-472-5013
September 2000

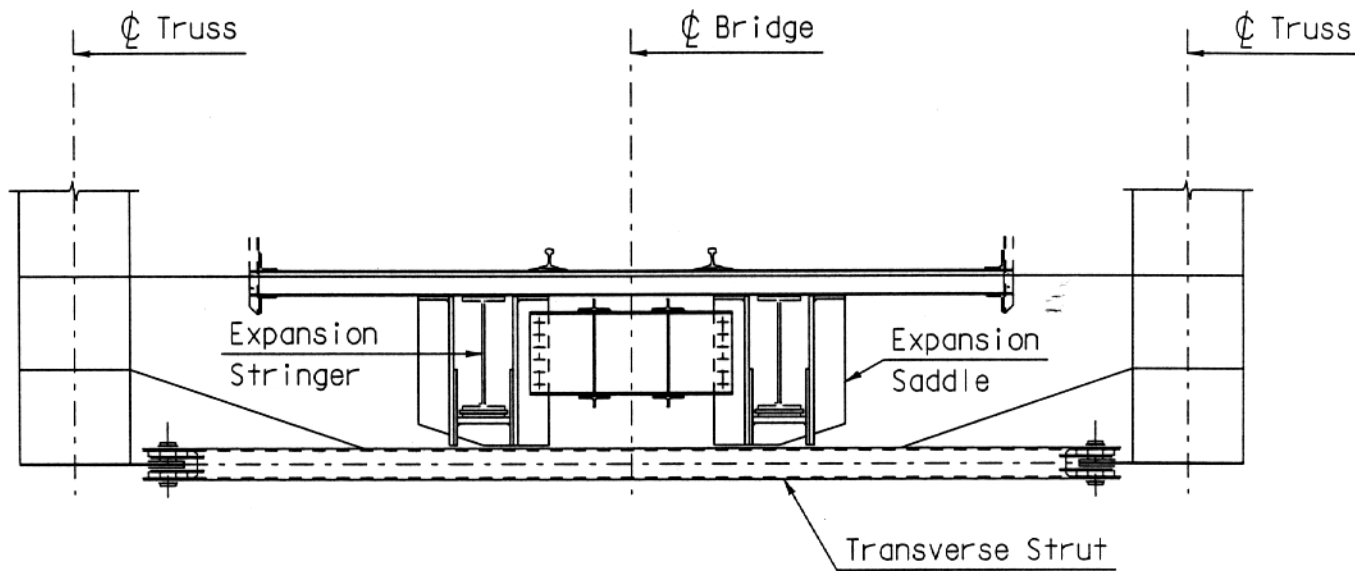
Figure 2. Typical Section - Expansion Joint

The field inspection in 1994 verified that the top rollers were rusted to the pin and stringer bearing plate and that the oil holes were plugged with dirt. The assemblies at the expansion joints shifted towards the centerline of track and the inside of the assembly were wearing into the stub bracket plate since the link-pin arrangement was not functioning as originally intended.

- The top angles of the stub brackets were very badly corroded and cracked.
- The top angles of the cross frame in the stringer span adjacent to the expansion joint were severely corroded.

- Holes in the floorbeam web on the backside of the expansion joint at the bottom of the stringer to floorbeam connection had developed. A reinforcing plate had been riveted to the floorbeam web on the expansion joint face to strengthen this area. This plate was added when the other expansion joint repairs were made.

- The floorbeam web below the bottom of the stringer was buckled locally due to a horizontal force induced into the web by a force couple from the stub stringer.

- The transverse strut connecting the lateral bracing member in the expansion panel to the bottom chords was also heavily corroded. The expansion joint struts had been repaired in the past by splicing angles and plates to the member. The original configuration of the transverse strut has contributed to the deterioration of the member as the original top member was fabricated of a 12" channel with the flanges turned up. By design, this detail retained debris and water. The pin connections at the lateral connections to the chord gusset plate were also heavily corroded.

The leaking of the fire protection waterline expansion joints had exacerbated the extensive deterioration at the expansion joint panels. Weep holes drilled into the 12" channel were not effective because of accumulated debris.

After meeting with the BNSF, it was decided to detail an assembly that would require minimal maintenance in the future. The following design concepts were adopted. See Figure 2 for a typical section at the expansion joint.

Based on results of the inspection and concerns of the BNSF, it was decided that the expansion joints in the floor system should be rehabilitated due to extensive corrosion and wear in the pins and bars of the expansion joints. The existing joints were last rehabilitated in 1951 by replacing pins, bars and castings. Because of the deteriorated condition of the stringers at the expansion joint, it was decided that the stringers would be replaced in conjunction with the expansion joint replacement. Repair schemes for the existing stringers were considered but complete replacement was determined to be more economical.

A rolled beam section fabricated to be installed as a complete unit replaced the expansion panel stringers.

Review of the existing plans indicated that a stringer saddle device similar to what has been used at other BNSF bridges could be designed to handle the anticipated magnitude of movement at the expansion joint. The saddle connection utilized existing rivet holes in the floorbeams. The use of the saddle would cause some increase in the eccentricity of stringer reaction to the floorbeam; however, details were developed to minimize eccentricities. Expansion in the truss floor system was accommodated through the use of a Teflon faced plate attached to a saddle bracket, allowing the stringer span to expand and contract. The saddle and bracket was designed to accommodate a total movement due to temperature and live load of 20

inches. The assembly was made up of plates welded to form the saddle. The saddle was designated fracture critical material and was stress relieved after fabrication.

It was decided that the existing struts at the expansion joints should be replaced because of extensive deterioration. The built up sections were replaced with a structural tube section that replaced the original area of the built-up strut sections. The tube shaped member was used to eliminate water and debris accumulation on the strut since the existing waterline on the bridge has a tendency to leak at the truss expansion joint.
