Restoration of the Machu Picchu Railway Line after the January 2010 Floods

Cesar del Carpio Polar, Director of Engineering, Ferrocarril Transandino, SA
Arequipa, Peru

James Michel, P.E. Senior Vice President, Marsh Global Rail Practice
Washington, DC

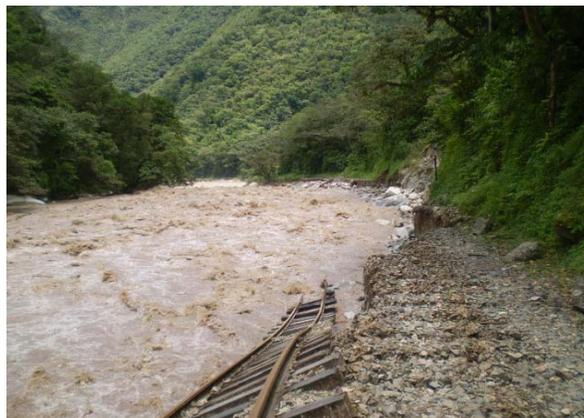
Figure 3

In December 2009 and January 2010, rainfall in the watershed had been heavier than normal and river levels were high. The region historically experiences flooding conditions every four to five years with limited damage to crops and highways. The railway line due to its precarious location adjacent to the river, has been interrupted multiple times over the past decade. The weather in Cusco state turned even wetter around January 20 with heavy showers and high bursts of rainfall that raised the river levels significantly and flooded huge expanses of the valley. Throughout the month of January, forces of FTSA had been stabilizing the alignment with sandbags, gabions, and additional fill. The rainfall climaxed between January 24 and 26 when the railroad was closed at multiple locations with mud flows and washouts. See Figure 3.

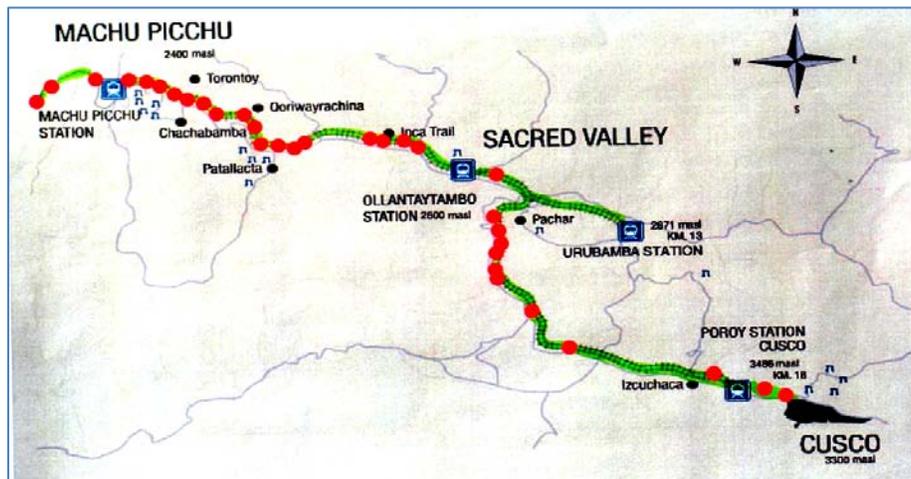
The line was washed out or inundated by mud slides and rock falls at 44 locations, the majority between Ollantaytumbo and Aguas Caliente. See Figure 5.

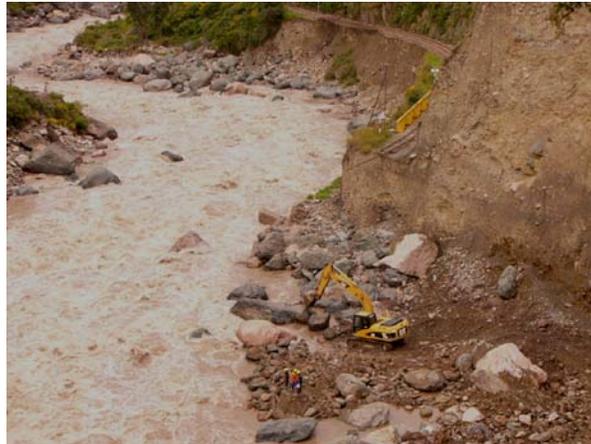
The worst condition was at KP79 where close to 600 feet of alignment was scoured away and the river had eaten into the hillside well beyond the centerline of track. See Figure 6 taken in late March, 2010..

At this location, the top of rail was 30 feet above the river which meant a large fill or a totally new alignment would have to be created.

The biggest challenge was the washout at KP79 between Ollantaytumbo and Piscacucha. At this location, the river had cut well behind the centerline of track. The repair method selected was to construct an engineered fill faced with gabions. This new fill was 600 feet in length and close to 30 feet high. The fill was reinforced with geo-mesh plastic grid mats and tiebacks to anchor the gabions. The bottom of the wall was armored with concrete and rock to reduce likelihood of future scouring. See Figures 12 and 13.

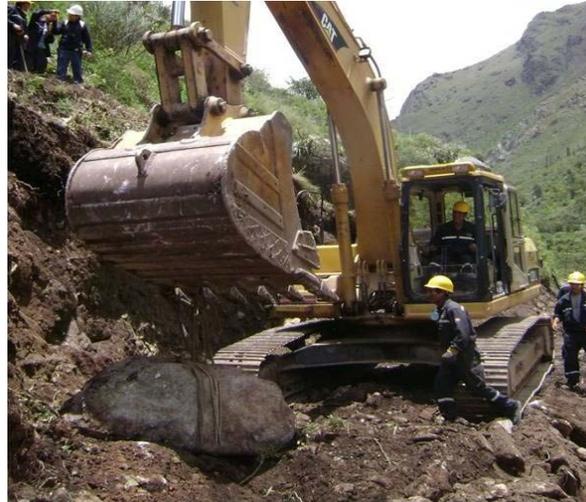
Figure 7

Except in locations with solid rock, the soil conditions are generally loose deposits and clays with cobbles that have washed down from higher elevations over the years. This caused significant mud and rockslides that would ultimately provide much of the material to reconstruct the line. Lack of heavy earthmoving equipment meant that indigenous materials would have to be used for repairs. See Figure 7. Due to their portability, the most universal

building element turned out to be wire cage gabions filled with local river excavated cobbles. Tracked hydraulic backhoe excavators were the primary machines used because of their immediate availability at several locations.
