1995 SPRING WASHOUTS IN BRITISH COLUMBIA

John Unsworth

**Manager of Bridge and Structures Construction
CP Rail**

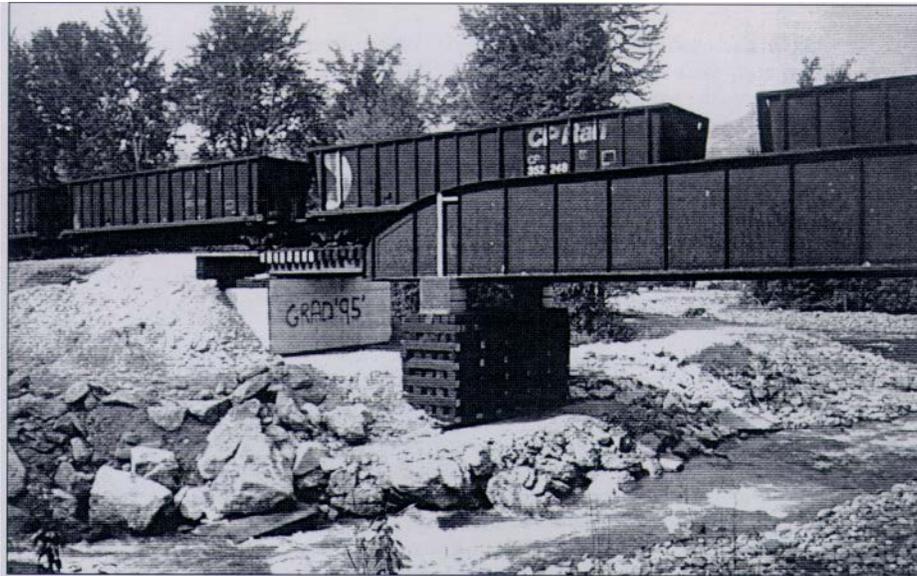
Bridge 36.67 Cranbrook Subdivision. Temporary reconstruction completed.

It was decided to remove the west abutment and effect a temporary reconstruction scheme which would render the bridge serviceable as soon as possible and enable the reconstruction of a new permanent reinforced concrete abutment under traffic. Temporary timber crib substructures were constructed with a temporary steel flanking span. The following is a synopsis of the temporary reconstruction sequence.

- Construct foundation and temporary timber crib abutment. Backfill temporary timber crib abutment and approach.
- Install temporary steel flanking span (a 25 foot steel I-beam flanking span, complete with diaphragms and bracing, was fabricated and assembled at the site with clip angle connections for attachment to the TPG end floorbeam and bearing pads at the other end for bearing on temporary timber crib abutment).
- Install deck (prefabricated and framed at site).
- Complete backfilling, ballast, construct and surface track.

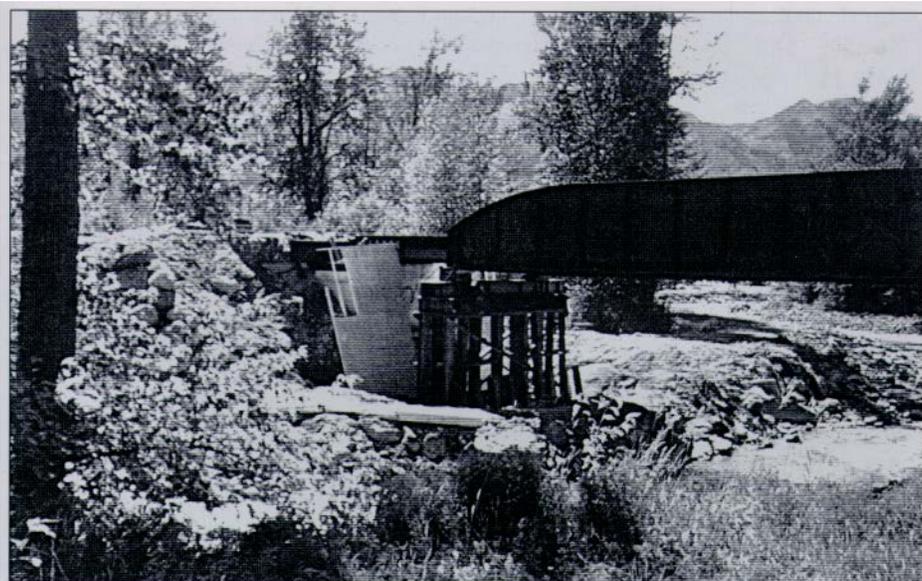
Bridge 36.67 Cranbrook Subdivision. Span supported on temporary steel bent and formwork for permanent abutment being constructed.

The work of permanent reconstruction at 36.67 Cranbrook commenced the week of July 3 with the driving of piles for the abutment (piles were driven between the temporary steel flanking span stringers after ramp construction for placing the pile driver leads) construction of a temporary steel bent and removal of the timber crib pier supporting the bridge since June 12.

Construction of formwork reinforcement placement and concrete pouring around the temporary steel bent and foundations piles (cut off above ground elevation at three feet and six feet for back row and front row piles, respectively) proceeded under traffic.

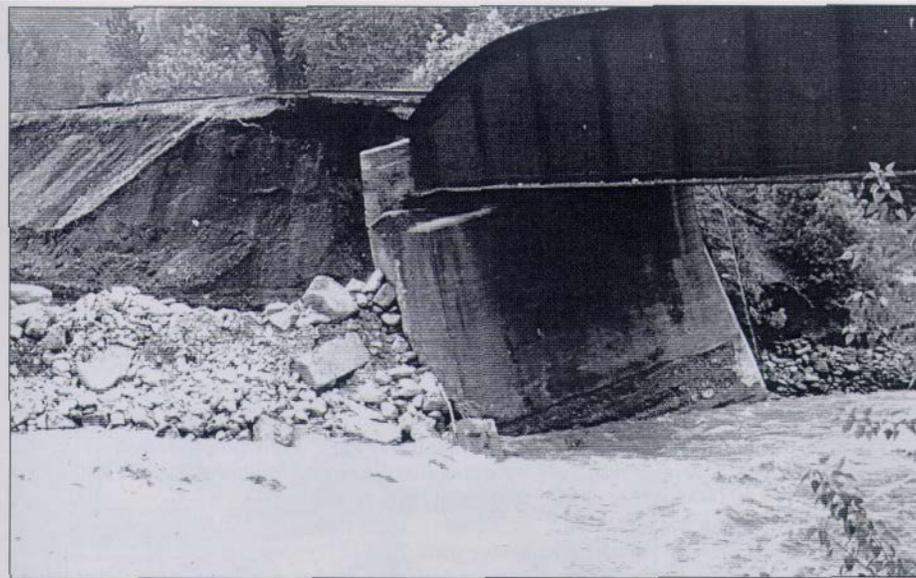
The greatest constraint to the restoration of coal line operation was the bridge reconstruction required at mile 36.67 Cranbrook subdivision. The bridge at 36.67 Cranbrook subdivision is a 100-foot through plate girder (TPG) span supported on concrete abutments constructed in 1910. The 23-foot tall abutments were constructed on spread footings founded on rock-filled timber cribs. On June 6, the bridge experienced a complete loss of the railway embankment behind the west abutment and the scouring of the west abutment foundation. As a result of this footing undermining, the west abutment tipped an estimated 15 degrees southward. While the substructure was damaged beyond repair, the superstructure, even though twisted along its length remained undamaged due to the flexibility afforded by the open plan (stringer/floorbeam) floor system between relatively stiff girders.

Bridge 36.67 Cranbrook Subdivision failed west abutment.

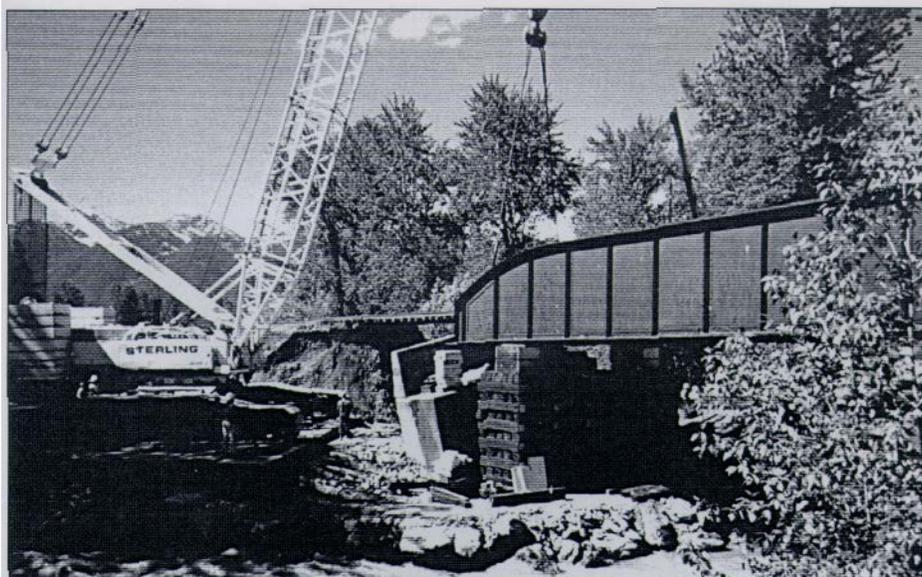
Bridge 36.67 Cranbrook Subdivision supported on temporary timber crib pier.

- Construct foundation (compacted pit-run crushed rock for temporary timber cribs) and construct the temporary timber pier crib to the east side of the failed abutment (a peninsula of large rock and compacted granular fill was constructed in front of the failed west abutment).

- Cut hearing anchor bolts and lift span onto timber pedestals on the temporary timber crib pier (the span was blocked and supported on the tilted bridge seat as pier pedestals were installed). This resulted in a 10 foot cantilevering of the TPG span at the west end, to which the temporary steel flanking span would be connected.

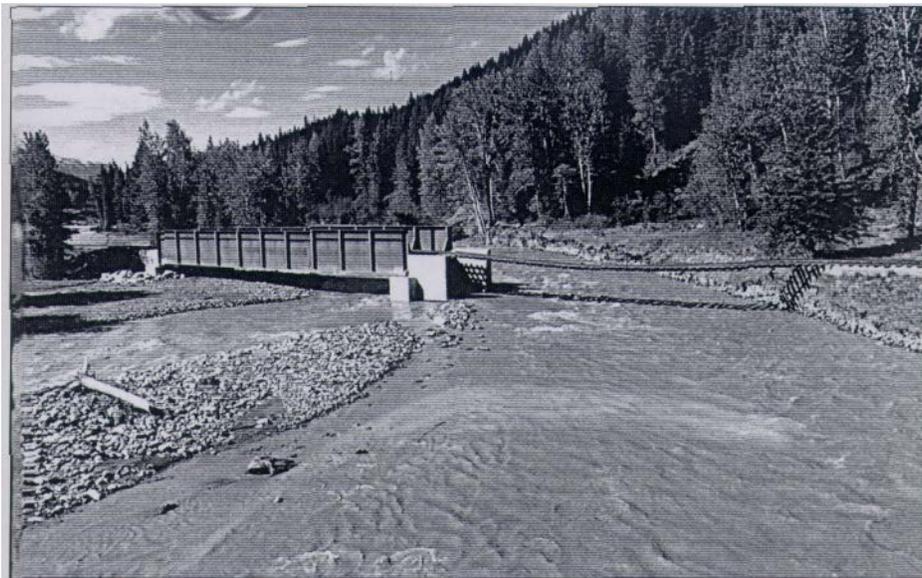
Bridge on Bryon Creek Subdivision washed out behind abutment.

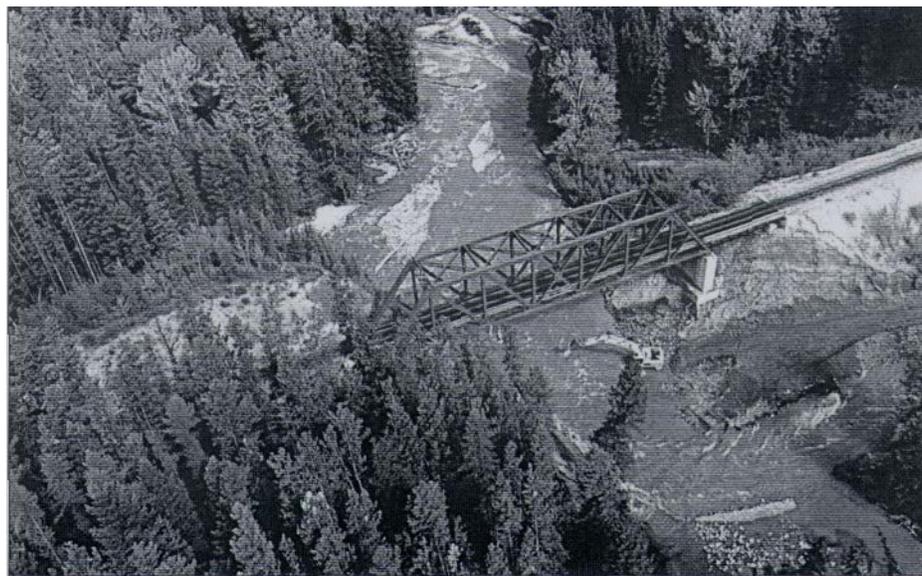
Bridge 12.2 Fording River Subdivision with piles exposed at pier.

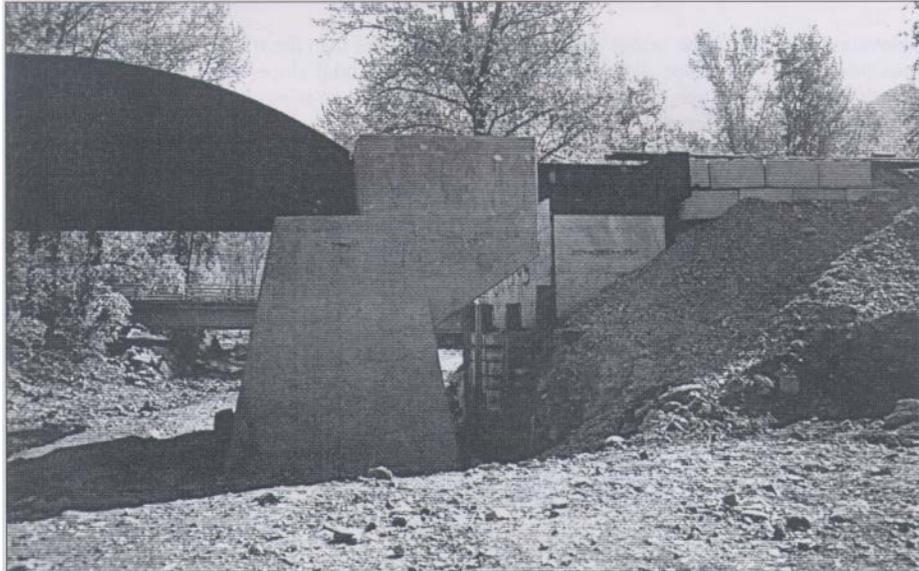
Bridge 36.67 with permanent abutment constructed.

After concrete curing to a compressive strength of about 4,000 psi, hearing installation, removal of temporary steel flanking span, and concrete pour completion (ballast wall pockets); backfilling, track construction, ballasting and surfacing will be performed to bridge to normal operation. The work of dike restoration and revetment protection of the dike and new abutment will be coordinated with municipal, provincial and federal agencies responsible for land, water, environmental and fish habitat protection.

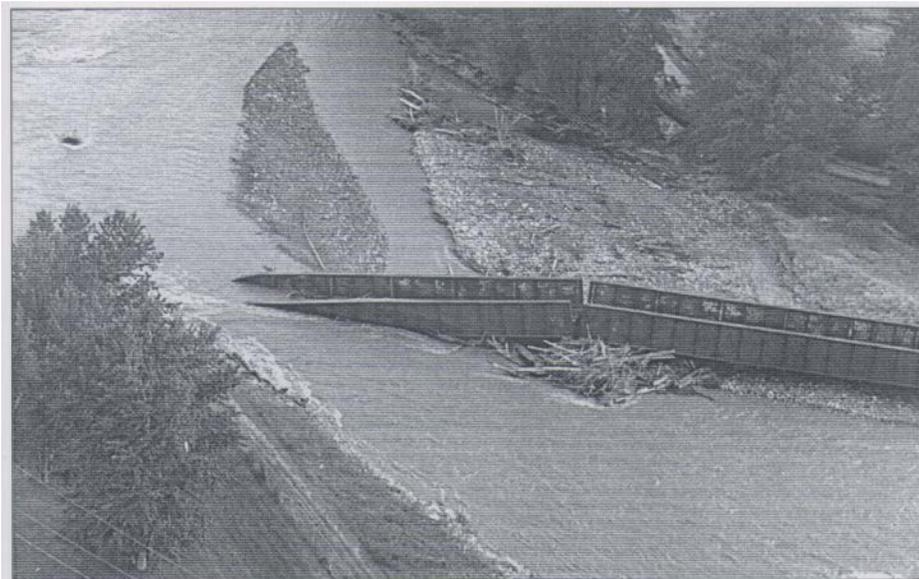
The bridge at mile 15.96 Cranbrook subdivision is a two span (two 110 foot TPG spans) structure supported on concrete abutments and central pier constructed in 1910 (substructures were repaired and jacketed in 1954). The June 6 flood event caused complete failure of the west abutment and embankment behind the abutment for a distance of about 300 feet after peak flows breached a dike immediately upstream of the bridge. The result was the subsidence of the west abutment and west end of the west TPG span into the river. The west TPG span was submerged over about half its length and displaced downstream about 20 feet at the west end. It was decided to reconstruct the bridge in a similar manner to that underway at mile 36.67. The immediate challenge, however, was to re-route the river under the east TPG span in order to construct the necessary access and crane pad to commence the reconstruction.

In addition to damage to the top flange angles of a stringer in the west panel of the west span, inspection of steel work revealed damaged intermediate web stiffeners and web plate on the south side of the west end of the west TPG span. Immediate repairs were made to the stringer flanges with other steel repairs being deferred, as it was determined the span was in acceptable condition to carry train loads at 10 mph commencing June 18.

Bridge 15.96 Cranbrook Subdivision washed out at west end.

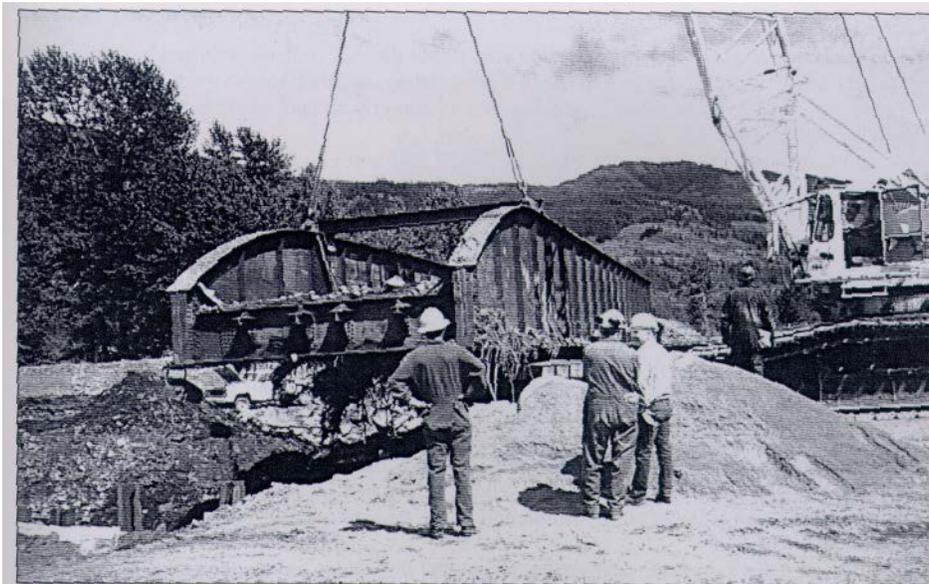
Bridge 15.96 Cranbrook Subdivision being lifted and moved laterally on to temporary supports.

- Install sliding devices in channel runways (Hillman Rollers), remove anchor bolts and install safety cables in TPG spans.
- Lift west end of west span (span was lifted from lugs with spreader beam as it was not possible to sling underneath submerged end of span).

- With crane at west end and cables attached to a dozer at the east end of the west span, slide span southwards and support west end on base of temporary timber crib abutment. The east end of the span rested on the glide/roller arrangement on timber blocking. The span was moved laterally about 20 feet in this manner to allow for the demolition of the failed abutment, driving of remaining piles for the temporary steel bent, steel bent construction and east end roller bearing inspection,

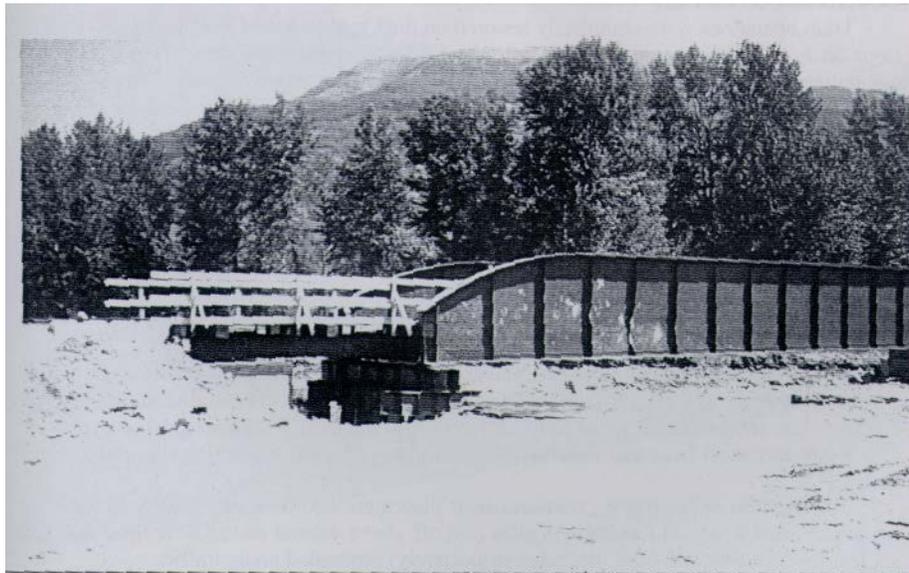
Bridge 15.96 Cranbrook Subdivision Temporary reconstruction completed.

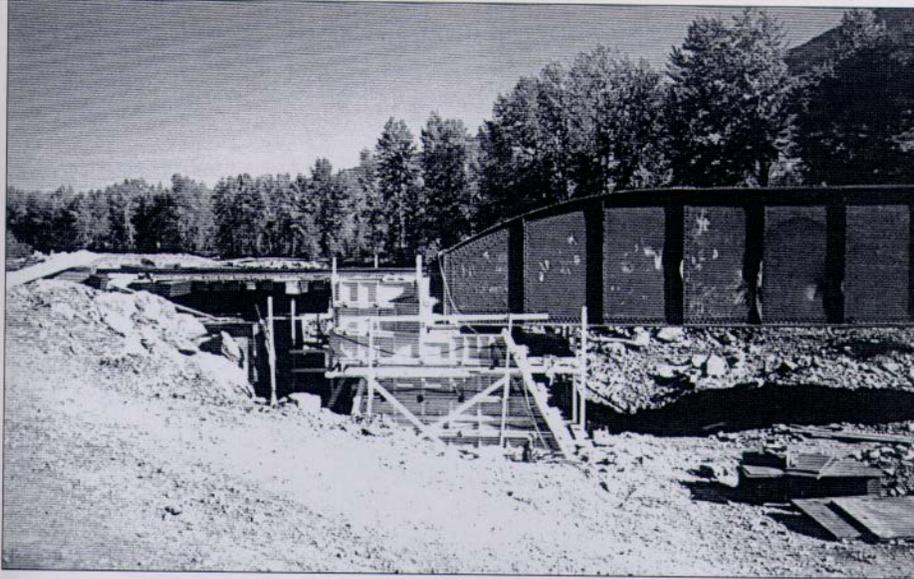
Bridge 15.96 Cranbrook Subdivision with formwork for permanent abutment constructed.

At 15.96 Cranbrook subdivision, an additional 11 piles were driven for permanent abutment (abutment pour commenced September 18). Land remediation. (like restoration, and revetment protection also remains at bridge 15.96. This work will be performed in coordination with local, provincial, and federal agencies. All permanent works are anticipated to be complete by October 1995.

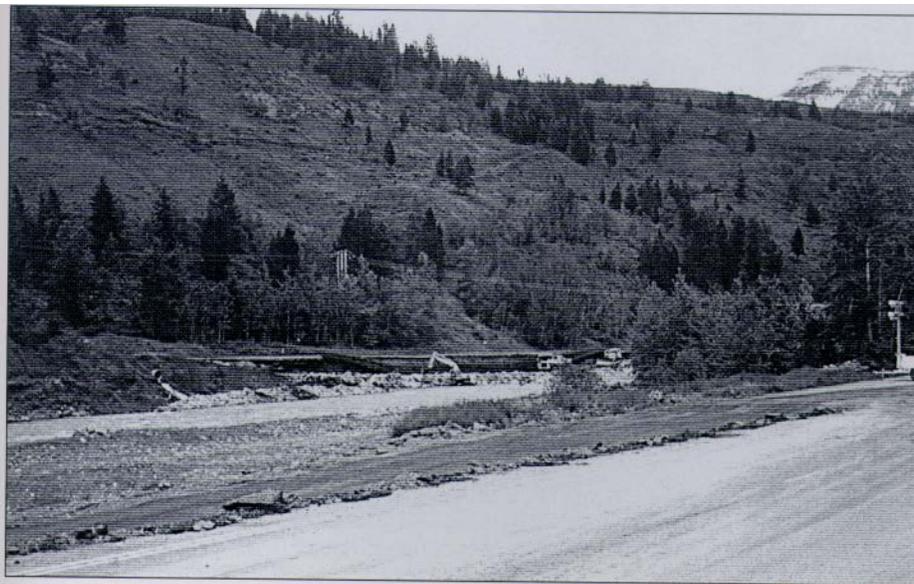
Concern over embankment foundation conditions (exposed and sloping bedrock) and high water at mileage 10.5 precipitated an investigation into slope excavation and realignment of the track. However, river training was successful and a stable rock foundation was placed enabling embankment reconstruction in its original location. Both embankments at locations at miles 10.5 and 11.0 were restored (large rock foundation with five feet of freeboard above high water level and granular fill placed and compacted), track constructed, ballasted, and surfaced by June 30. Rip rap was transported and deposited at locations where minor scouring occurred behind wing walls at bridges 8.9, 9.2, and 9.4 Cranbrook subdivision, thus completing (except for placement of rip rap at the bridges) the Work Area "A" project and opening this portion of the subdivision to traffic. Slow orders of 10 mph will remain on the bridges until the permanent reconstruction is completed, and on reconstructed subgrade until roadmaster's inspections reveal no further subsidence and surfacing requirements under load (after about 500,000 gross tons has passed over the affected areas).

Reconstruction of subgrade at mile 10.5 Cranbrook Subdivision.

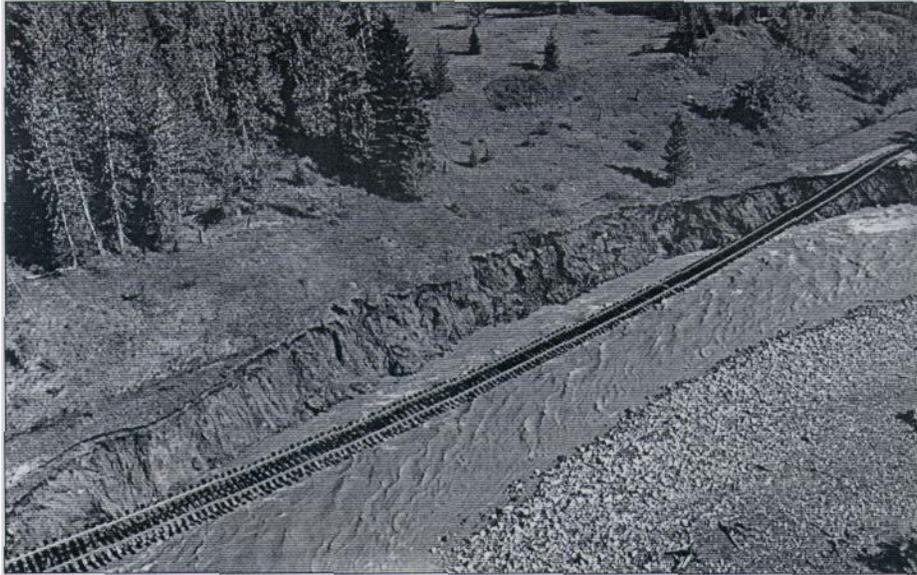
At 12.5 Cranbrook subdivision, only rip rap was required to stabilize the toe of the embankment. However, at miles 10.5 and 11.0, a combined length of about 350 feet of embankment was completely washed out leaving the track suspended. The embankment was restored, subgrade constructed, and track laid within 12 days of completion of the temporary reconstruction of the bridge at mile 15.96 Cranbrook subdivision.

Washed out embankment at mile 11.0 Cranbrook Subdivision.

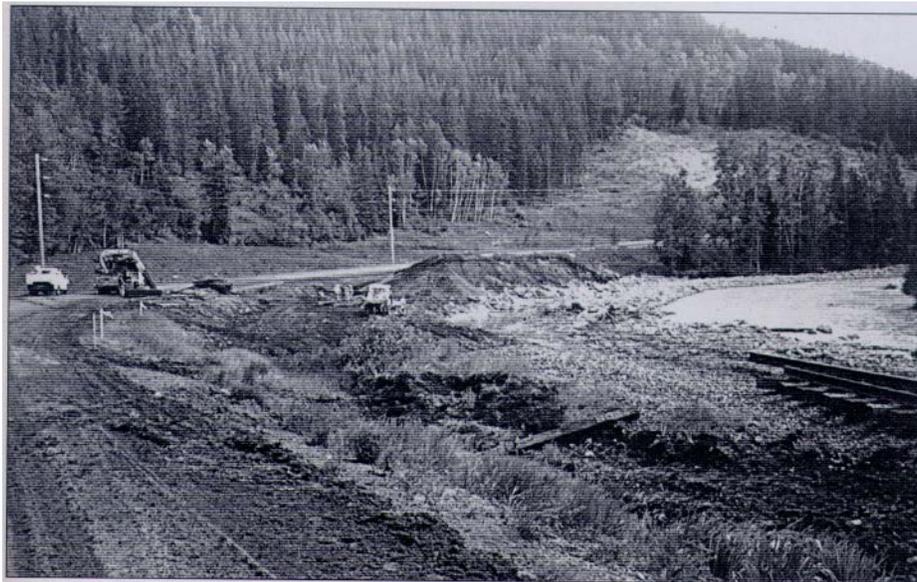
Work package "B" consisted of a washed out section of track at mile 8.5 Cranbrook subdivision. A 350 foot long section of the railway subgrade was scoured away to a depth of about 20 feet leaving the rails and ties of the 6 degree curved track hanging over the washed out embankment. In order to open this segment of track concurrently with those of work packages "C" and "D" (comprising the bridge at 8.24 and washed out subgrades at miles 6.9 and 7.3 Cranbrook subdivision), thereby restoring service on the Cranbrook subdivision east of Sparwood, BC (mile 17.7 Cranbrook subdivision), materials were transported to site by road commencing June 20 (river training completed and track removal began June 14).

Washed out embankment at 8.5 Cranbrook Subdivision.

Embankment reconstruction in lifts from imported rock and granular fill materials was completed by June 30. Track construction, ballasting, and surfacing was completed July 3 concurrent with the temporary reconstruction of bridge 8.24 Cranbrook.

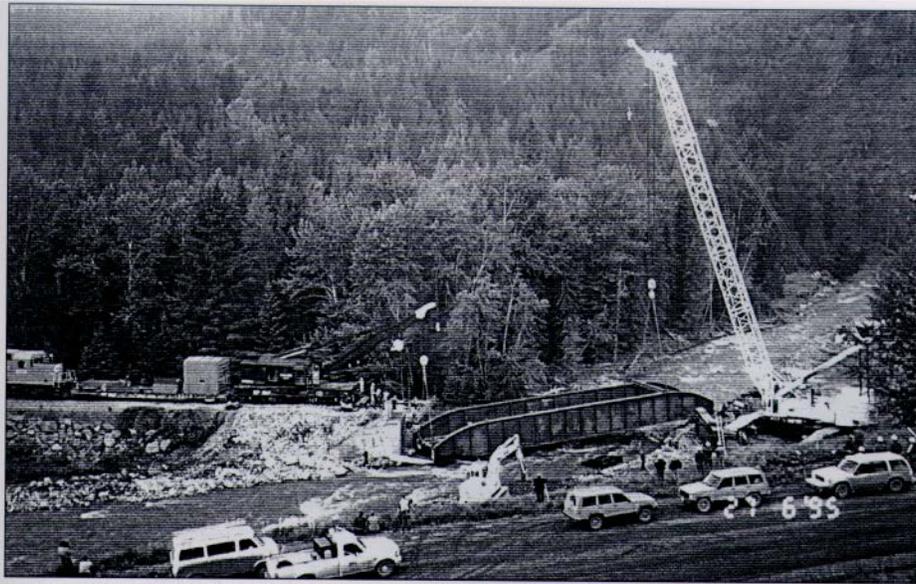
Bridge 8.24 Cranbrook Subdivision being lifted on to repaired east abutment and temporary steel bent.

- Temporary bearings of timber blocking, steel plates and angles were field constructed and installed at the east abutment.
- With the locomotive auxiliary crane at the east end and the crawler crane at the west end of the span, the cranes working in tandem lifted the superstructure into position on the repaired east abutment and temporary steel bent at the west end. The locomotive crane lifted its rated capacity of 35 T at a boom radius of 50 feet from the track on the east abutment, leaving the crawler crane to lift 80 T with a 60 foot boom radius (about 90 percent of rated capacity at radius of 60 feet).

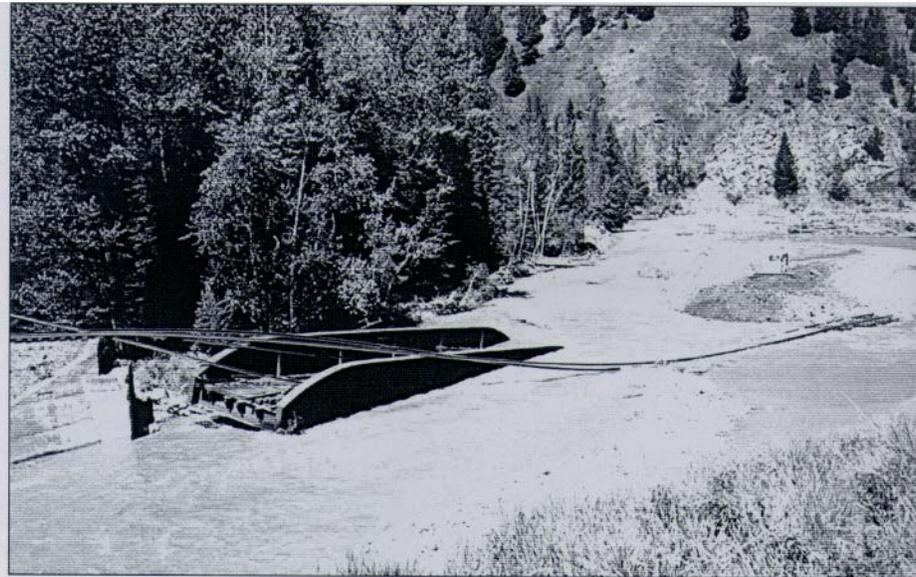
The bridge at 8.24 Cranbrook subdivision suffered extensive damage from the flood event river discharges of June 6. Similar to the flood damage experienced at bridges 15.96 and 36.67 Cranbrook subdivision, the railway subgrade west of the bridge and the west abutment of the bridge were washed away by the flood waters. This 103 foot TPG span erected in 1910 on concrete abutments on spread footings was lying in the river at all angle with its west end about 70 feet downstream. The west abutment had tipped into the river bed due to scour at the footing and the east abutment bridge seat and ballast wall were damaged when was pulled downstream as the west abutment failed.

Bridge 8.24 Cranbrook Subdivision West abutment failed and span displaced due to washout.

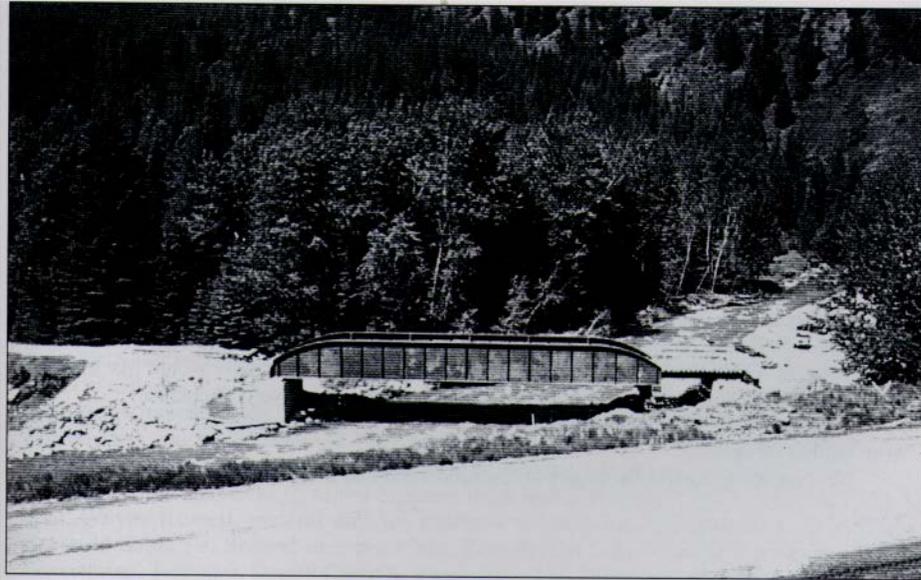
Bridge 8.24 Cranbrook Subdivision. Temporary reconstruction completed.

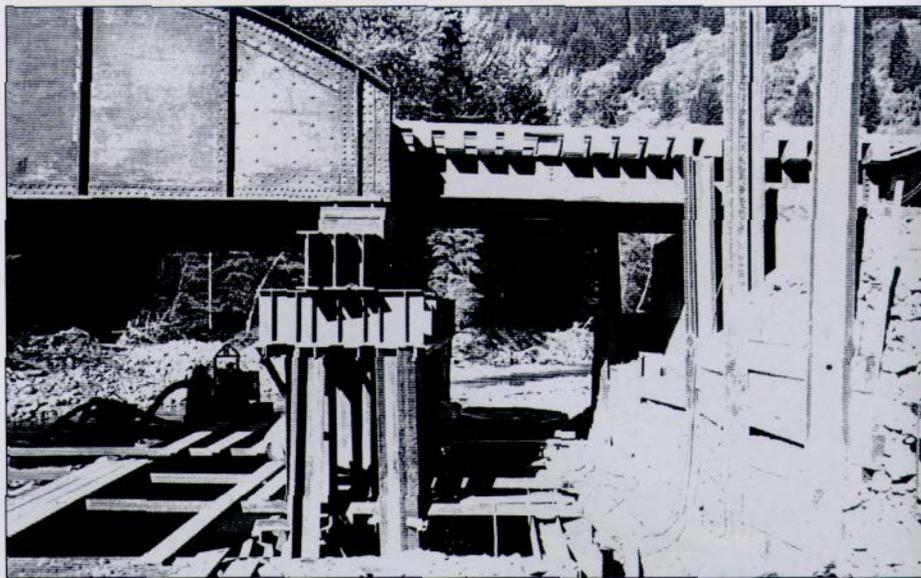
Bridge 8.24 Cranbrook Subdivision with cofferdam for permanent abutment footing constructed.

The bridges at miles 8.24 and 15.96 Cranbrook subdivision are being permanently reconstructed in a similar manner as the bridge at 36.67 Cranbrook subdivision (sheet pile cofferdams were required due to the water levels and depth of new foundations).
