**COMBINED APPLICATION OF ULTRASONIC INSPECTION AND ACOUSTIC
EMISSION MONITORING FOR EVALUATION OF FRACTURE CRITICAL
MEMBERS IN RAILWAY BRIDGES**

A combined, cost-effective inspection procedure, using ultrasonic (UT) scanning, or related NDT, to detect fatigue crack initiation and acoustic emission (AE) monitoring to assess crack activity, is presented. Application of this procedure to detecting and assessing fatigue cracks under rivet heads in hanger angles, in link pins and eye bars and in other fracture critical members is discussed. Specialized AE and UT procedures for bridge inspection are reviewed and a method of classifying fatigue crack severity is discussed. The incorporation of this type of inspection into a bridge maintenance program is discussed from a bridge owner's perspective.

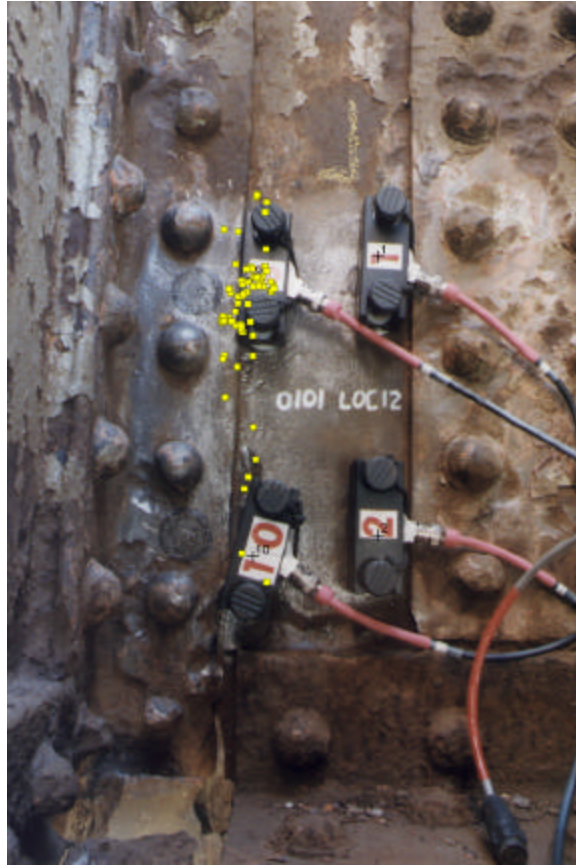
Figure 1. A cluster of source located AE events, with crack growth characteristics, between the fourth and fifth connection angle rivets.

The following presents several examples of using the above complementary test procedures to inspect known cracks in fracture critical members. The first example is the inspection of an existing crack in a floor beam web at its connection to a girder in a 100 year old through plate girder span. The crack originated in a corrosion-reduced groove at the bottom of the floor beam web, running 4 in (100 mm) upward, disappearing under the connection angle. Figure 1 presents the results of AE monitoring of this location. As can be seen a very active source was detected between the fourth and fifth rivets from the bottom of the web. Each yellow dot in this cluster represents a recorded AE event with the waveform characteristics of crack growth. Ultrasonic scanning was then used to confirm the presence of a crack under the connection angle. Although corrosion prevented continuous scanning, portions of the web could be scanned, confirming at total crack length of 15 in (380 mm), with the crack tip coinciding with the AE event cluster. Figure 2 shows the results of UT scanning, with detected crack indications drawn in white. Based on AE monitoring results, UT scanning results, corresponding strain measurements and related visual inspection, it was concluded (Table 1) that this location had a fatigue crack index, $D = 5$, with a recommendation for immediate retrofit.

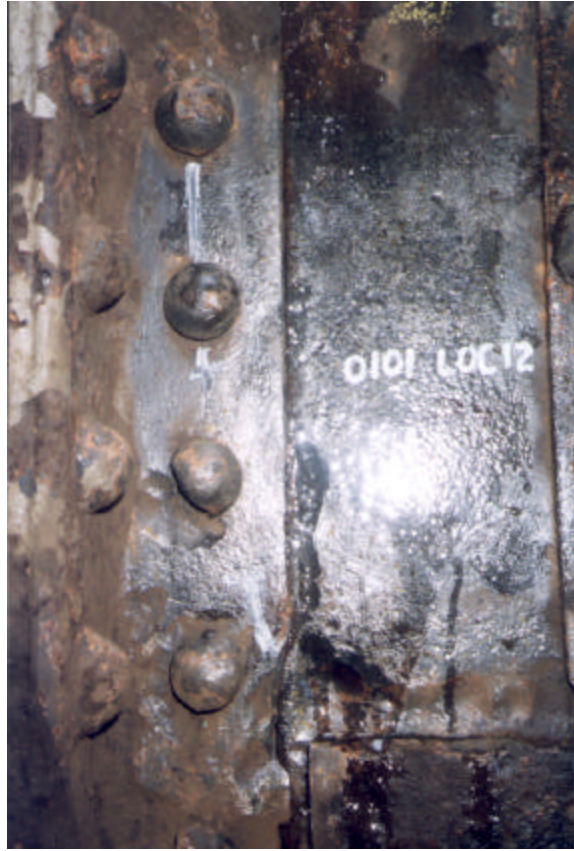
Figure 2. Ultrasonic scanning results of the same location as shown in Figure 1. Note the location of the crack beneath the connection angle, ending between the fourth and fifth rivets.

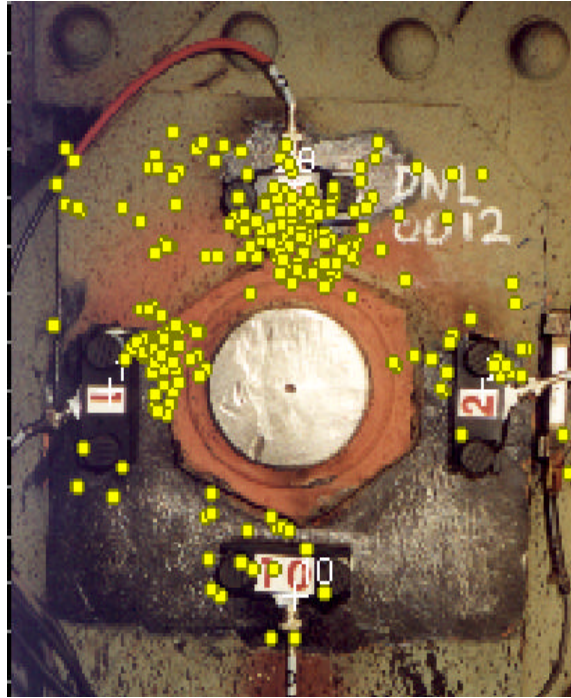
Figure 3. Results of AE monitoring of an eye bar. A 0.04 in (1 mm) deep crack had been detected with UT at the left critical eye bar section under the pin-retaining nut.

Figure 3 presents another example of combined monitoring results on one of the link pin and eye bar hanger assemblies connecting the stringers of a 93 year old deck truss span to a through truss span. Ultrasonic scanning, using specially fabricated calibration blocks and pins, was first conducted on the upper and lower pin and eye bar assemblies to check for the presence of cracks or indications at critical cross sections. Any locations showing UT indications were then subject to AE monitoring to assess crack activity. Figure 3 shows the results of AE

monitoring on one of the top outer eye bars. UT scanning had detected a 0.04 in (1 mm) deep crack, through the left inside of the eye bar, under the pin-retaining nut at its critical region. The AE data presented in this figure are coarsely filtered and include several types of signals, however a number of the events in the left cluster, which coincides directly with the crack location, had unique characteristics related to crack growth. It was concluded that this location had a fatigue crack index, $D = 3$ and it was recommended that this location be inspected on a scheduled basis.

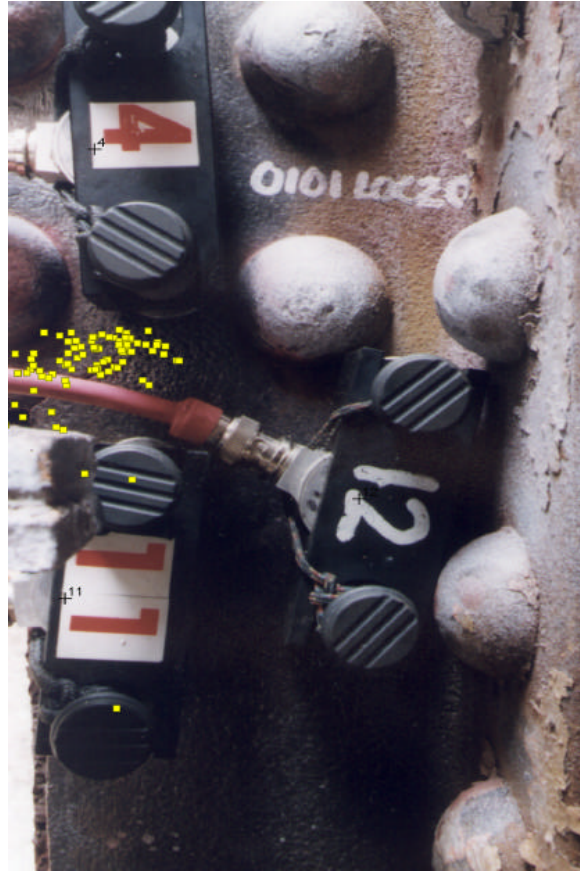
Figure 4. AE monitoring results from a crack originating in the cope of a floor beam connection angle. PT inspection confirmed that the tip of the crack was at the center of the cluster of located AE events.

Finally, Figure 4 shows AE monitoring results at a crack originating at the cope of the connection angle between a floor beam and girder on a through plate girder span. Although only the root of the crack was visible, dye penetrant testing indicated that the crack was over 1 in (25 mm) long, ending at the center of the cluster of AE events. The individual AE events all had waveform characteristics related to crack growth. Based on AE monitoring results, PT testing, strain monitoring and related visual inspection, it was concluded that this location had a fatigue crack index, $D = 3$. Scheduled inspection of this location was recommended.
