Fatigue Strength of Solid Sawn Timber Railroad Bridge Stringers

A.S. Uppal, Transportation Technology Center, Pueblo, Colorado

ABSTRACT

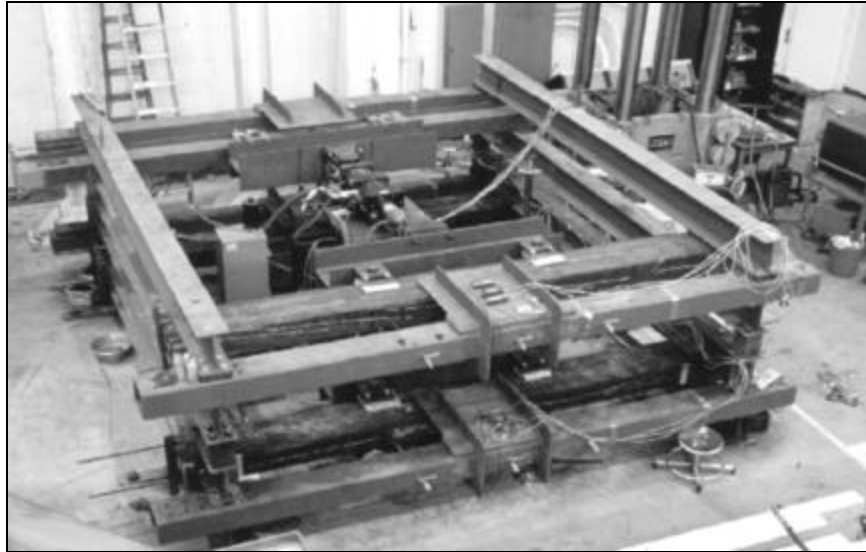
Figure 3.

A two-level loading frame was designed and fabricated to allow four stringers to be tested simultaneously at a maximum loading frequency of 3 Hz. The frame was adjustable for specimens with spans of 12 to 15 feet, widths up to 9 inches, and depths up to 20 inches. The frame consists of two sub-assemblies with identical dimensions and capacities with an ultimate design load of 110 kips. Test specimens were supported simply and subjected to 4-point bending. The initial levels of pulsating load were determined based upon the monotonic test results. Subsequent fatigue load amplitudes were selected based upon cumulative fatigue test data. These loads produced theoretical shear stress values that ranged between 100 and 500 psi. Figure 3 shows the loading frame for fatigue tests.

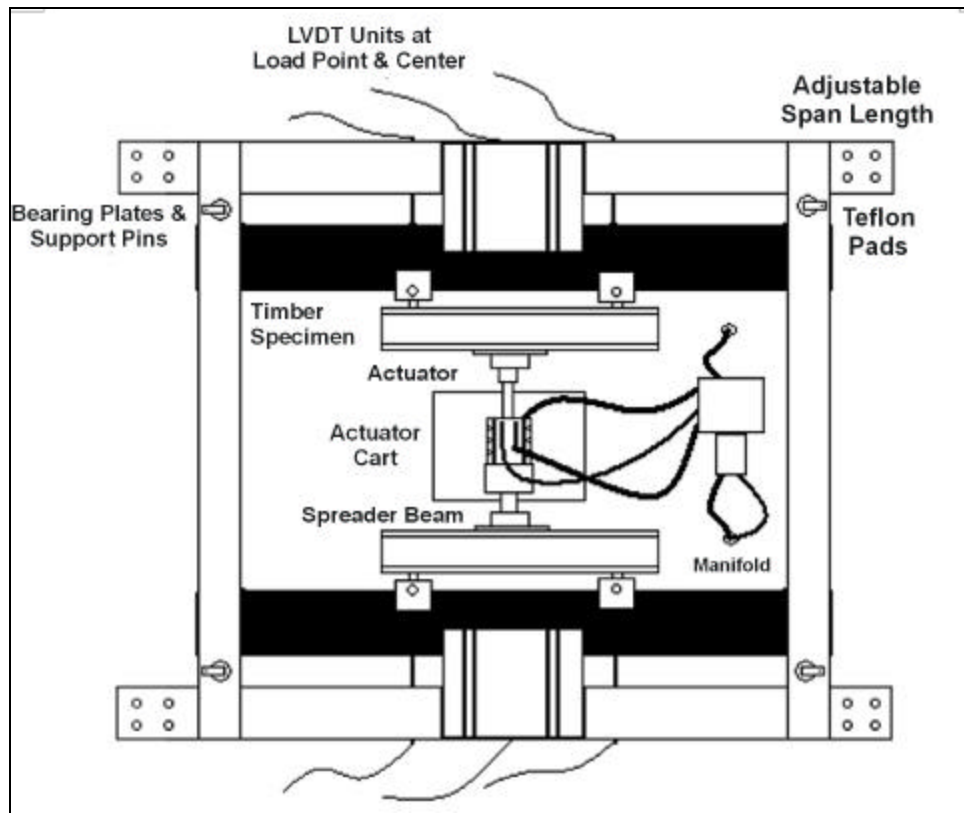
Figure 4.

A central computer controlled the tests and recorded the output of the load cells and displacement transducers. There were three displacement transducers for each specimen? one placed at midspan and one at each of the two load points. This arrangement of displacement measurements allowed for determining bending deflection and flexural stiffness in the constant moment region of the specimen independent of shear deformations in the remainder of the beam.

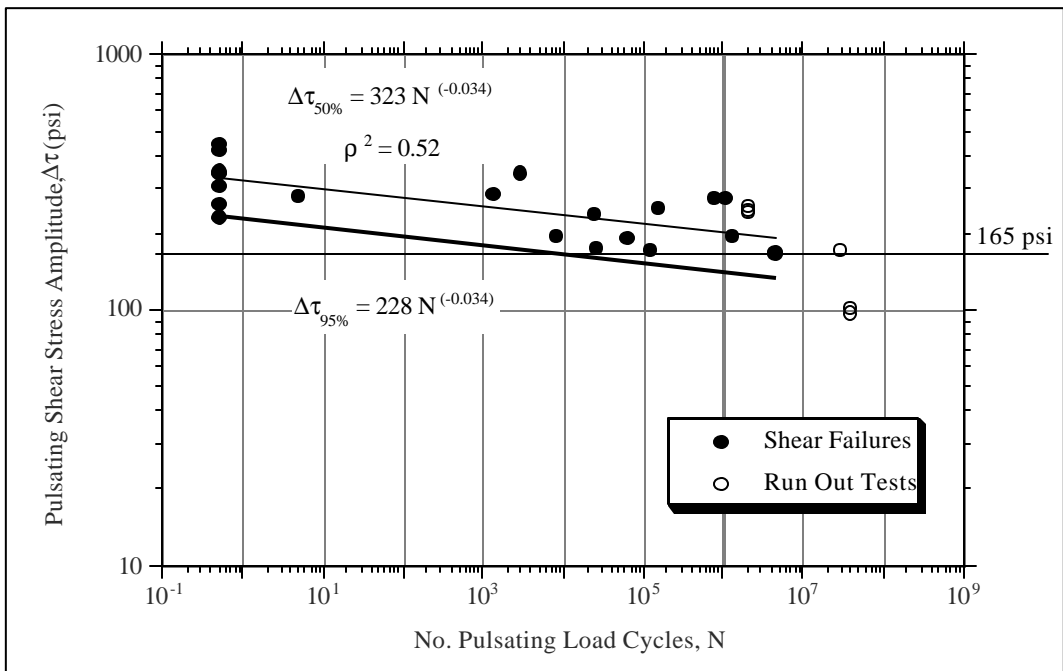
Figure 5.

Figure 5 is a plot of pulsating shear stress amplitude versus pulsating load cycles from the tests on southern pine stringers.(2) Both axes of the plot are drawn to a logarithmic scale. A mean regression line was determined through a least-squares-fit procedure whereby the error of estimating stress was minimized for observed cycles to failure. Run-out tests were not included in the regression calculations. The lower 95 percent confidence limit is also indicated on the plot and substantial variability in timber fatigue strength is readily noticeable.

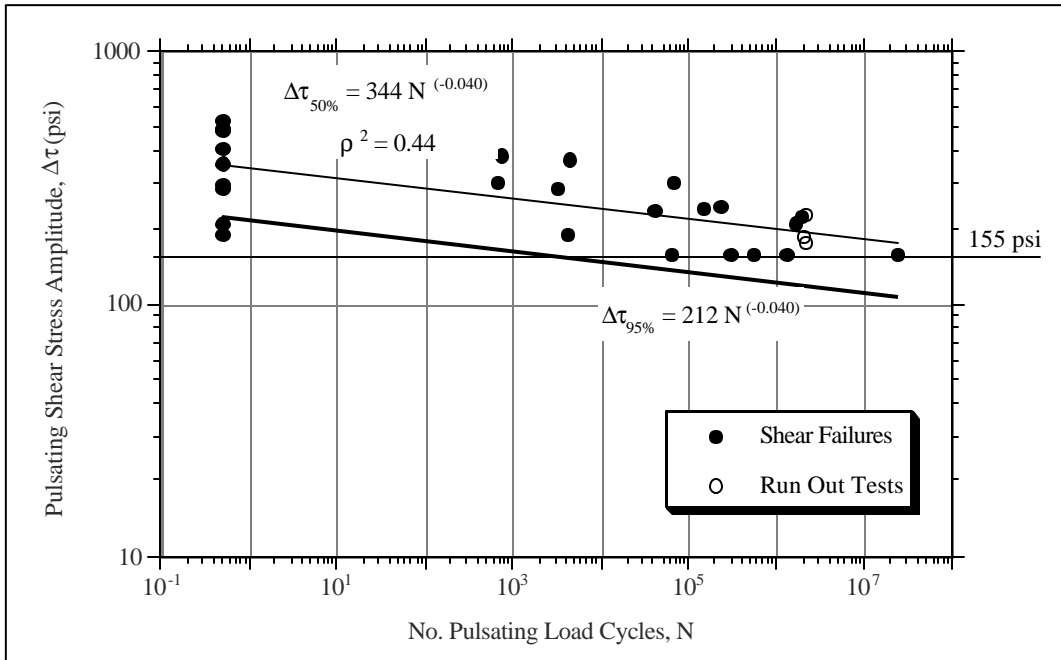
Figure 6.

Figure 6 is a plot of pulsating shear stress amplitude versus pulsating load cycles from the tests on Douglas fir stringers. As in Table 2, both axes of the plot are drawn to a logarithmic scale. A mean regression line was determined through a least-squares-fit procedure whereby the error of estimating stress was minimized for observed cycles to failure; run-out tests were not included in the regression calculations. The lower 95 percent confidence limit is also indicated on the plot. Substantial variability in timber fatigue strength is again readily noticeable in this plot.

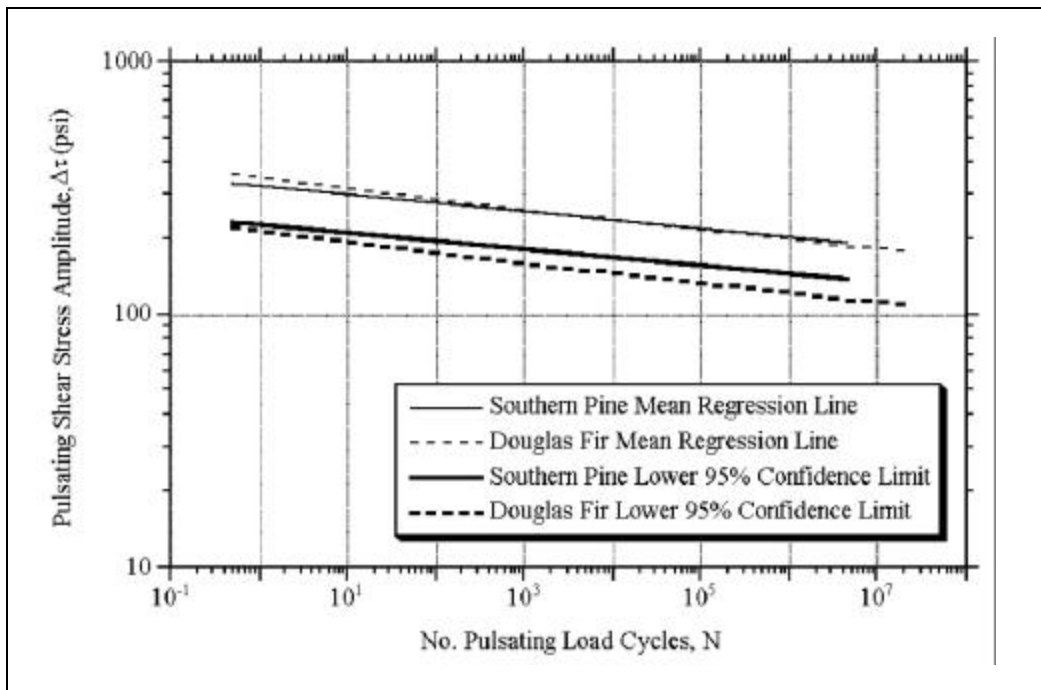
Figure 7.

Figure 7 is a plot comparing the strength characteristics between southern pine and Douglas fir stringers. There is very little difference in fatigue strength apparent between the two species. However, the Douglas fir has a slightly larger variance than the southern pine and demonstrates a bit more sensitivity to pulsating load. As a result, even though the Douglas fir obtains a larger mean static strength than the southern pine, the lower 95 percent confidence limit is less favorable for the Douglas fir than for the Southern Pine.
