Restoration of the Machu Picchu Railway Line after the January 2010 Floods

Cesar del Carpio Polar, Director of Engineering, Ferrocarril Transandino, SA
Arequipa, Peru

James Michel, P.E. Senior Vice President, Marsh Global Rail Practice
Washington, DC

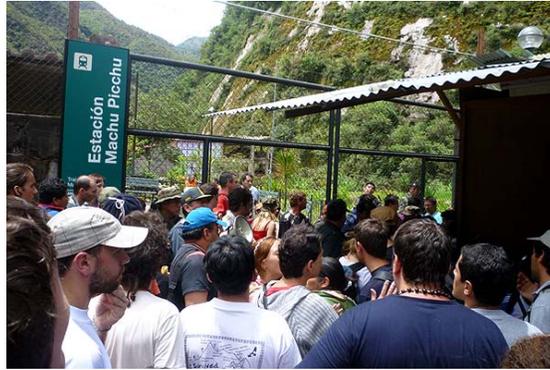
Figure 4

No trains were derailed or equipment lost but 2000 visitors were stranded in Aguas Caliente with no means to escape and with limited accommodation and food supplies. See Figure 4.

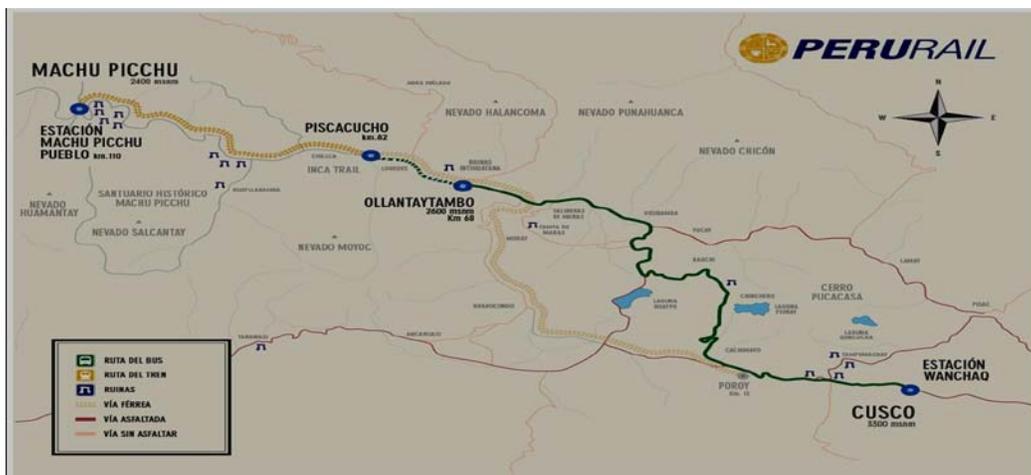
Figure 9

The second step of the recovery plan was to repair the tracks between Piscacucha (KP82) and Aguas Caliente (KP110) to allow a rail shuttle operation to meet buses at the end of the dirt road. PeruRail estimated they could have this service operating in eight weeks. Service commenced three days ahead of schedule on March 29 using the diesel rail cars that had been isolated at Aguas Caliente on January 26. Many of the repairs were temporary in nature and the diesel rail cars had lighter axle loadings than locomotives to facilitate an early start. The Cusco regional government constructed a temporary rail platform and parking area at Piscacucha to facilitate this service. See Figure 9.

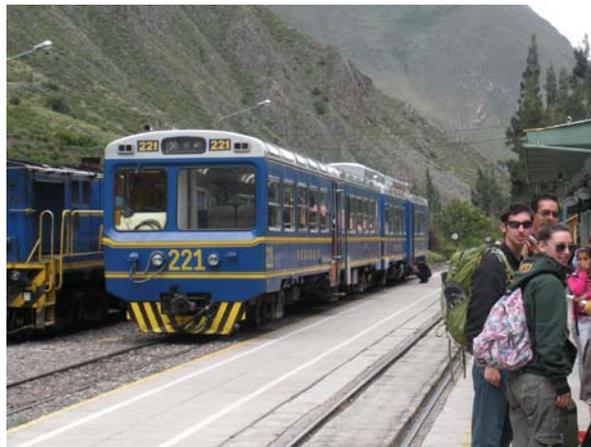
Figure 15

Work was completed on June 25 and after inspection by OSITRAN officials, the re-opening occurred on July 2, 2010. The July opening allowed PeruRail to retain almost all of its passenger traffic for 2010 by meeting the start of the primary travel season and addressing pent up demand from the five month closure. See Figure 15.
